Rural Contamination Scenarios

Lightning Ridge 2013

Malcolm Dale
Principal Environmental Scientist

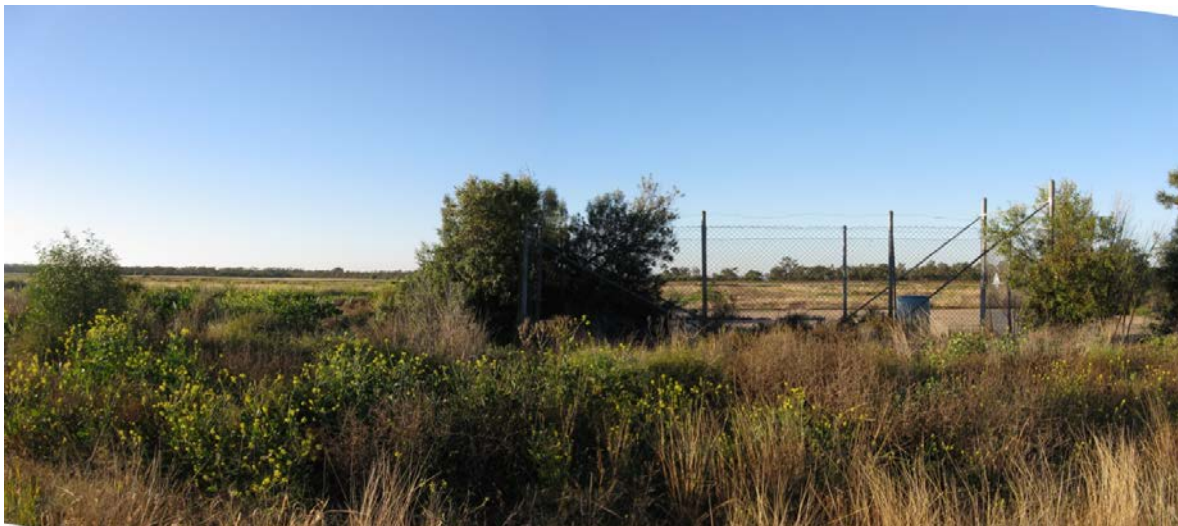
Sheep & cattle dips/sprays

Primary contaminant sources

Pesticide storage/mixing

Pesticide container disposal/washing out

Dripping animals/dip, holding yards, paths

Dip overflow

Seepage from base of dip

Air dispersion (from spray dip)

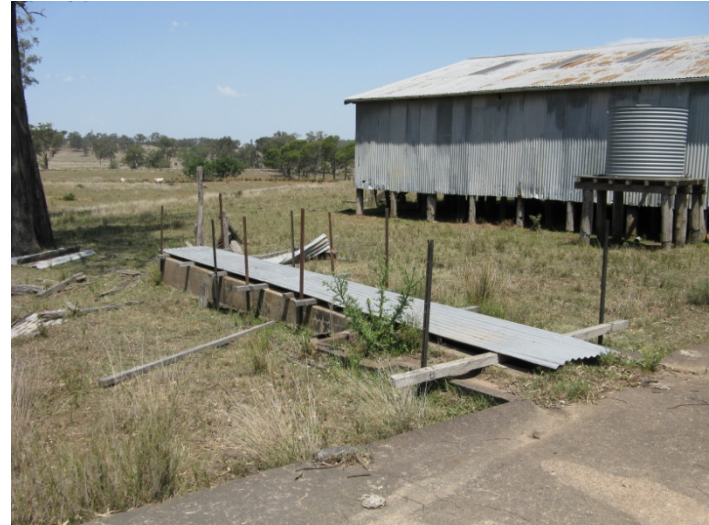
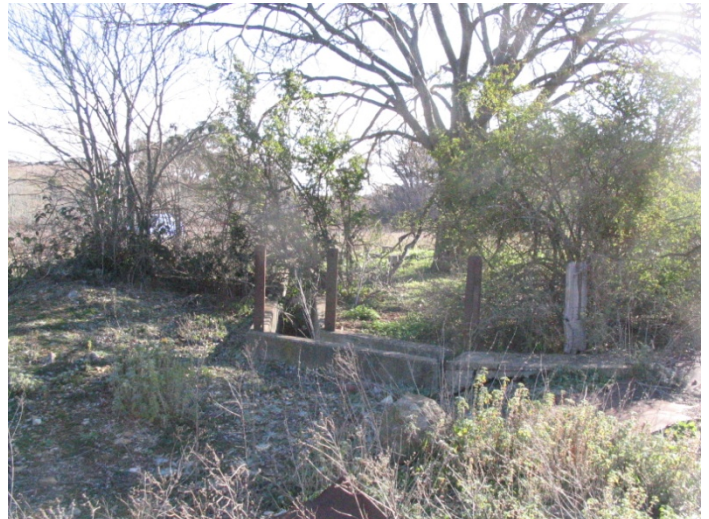
Depots/workshops

Primary contaminant sources

Fuel storage and dispensing

Waste oil tanks/sumps/spills

Bitumen/emulsion storage/use

Service pits

Waste including batteries

Chemical storage incl pesticides

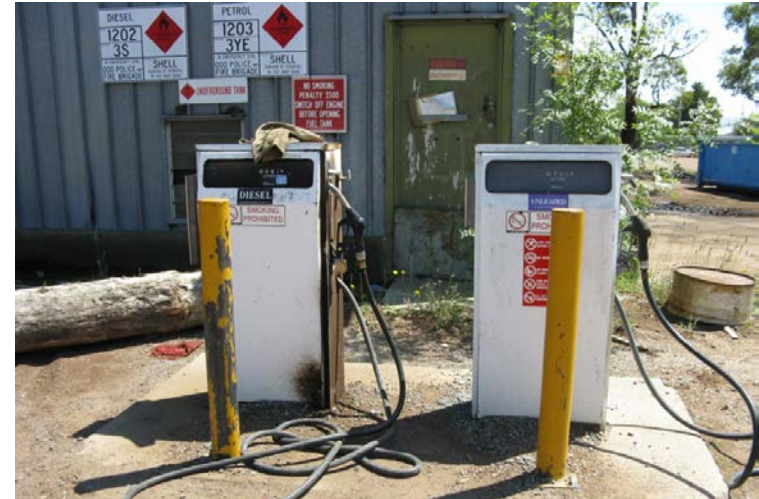
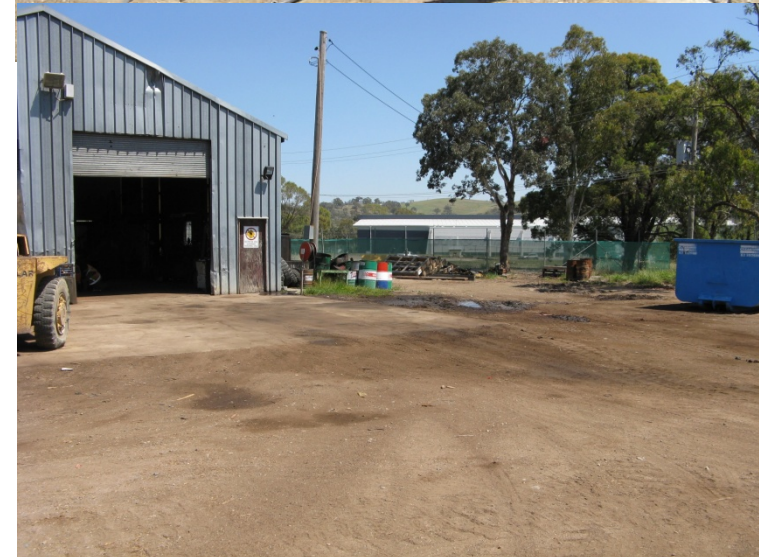
Farm tips/illegal dumping

Primary contaminant sources

Vehicle bodies/parts/waste oils/tyres

Pesticide containers

Fencing materials

Dead animals

Building materials (incl asbestos)

Household waste

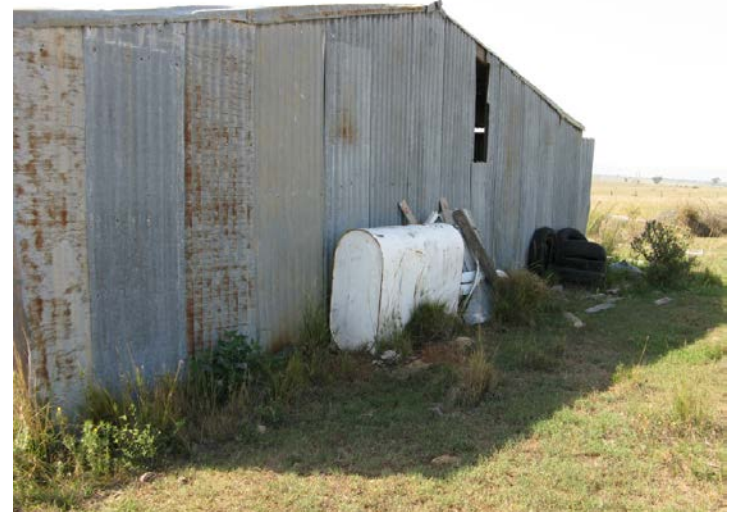
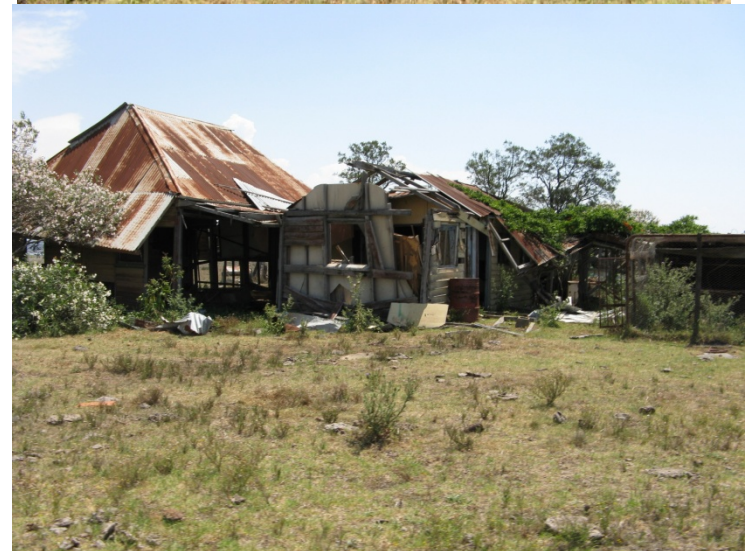
Farm buildings

Primary contaminant sources

Heating oil/fuel storage

Chemical storage

Asbestos building materials

Spills and leaks of hydrocarbons

Primary contaminants

Hydrocarbons

Heavy metals (particularly Pb)

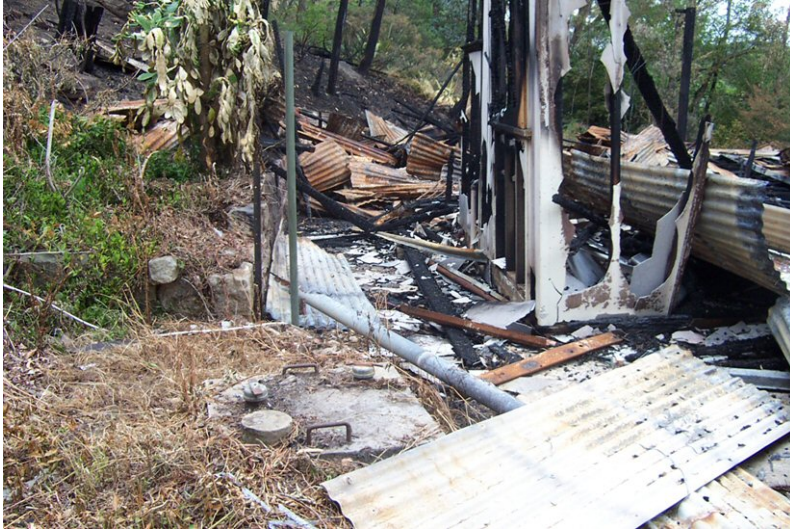
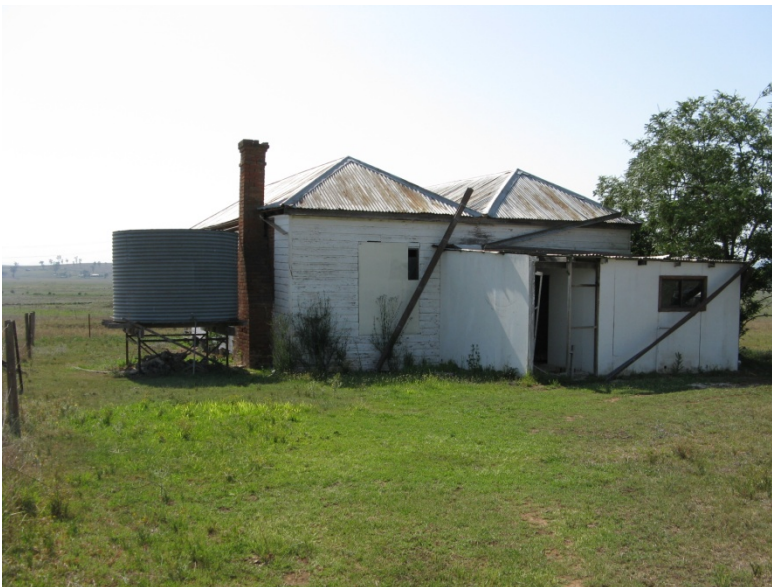
Asbestos in rural settings

- Derelict house burned by vandals. Asbestos cement sheeting explodes like stone on a fire and shards of fibro impact surrounding soils.
- Fire damaged fibro can also lose its integrity and be classed as friable asbestos.
- Abandoned houses/sheds on farms. Decay or demolition results in ACM fragments impacting soils

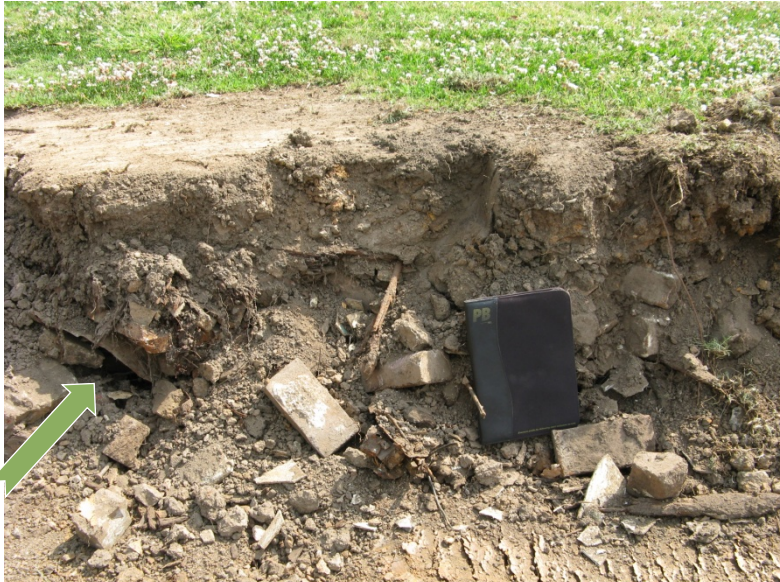
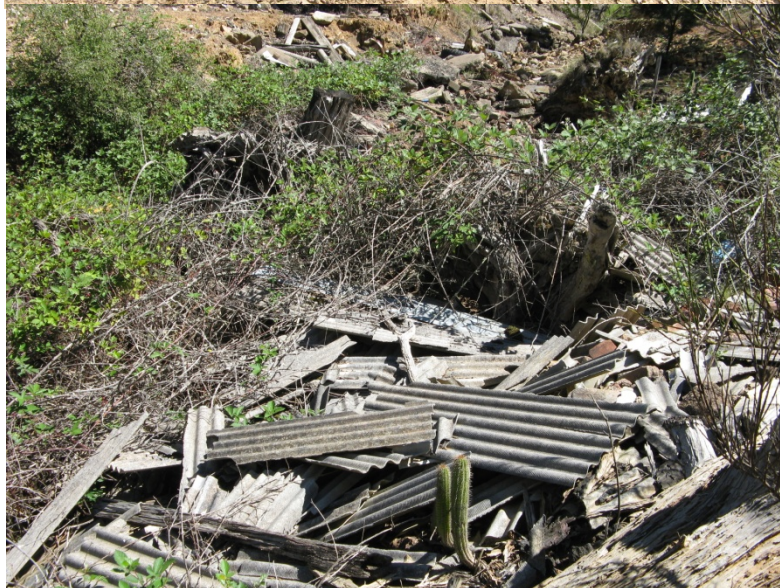
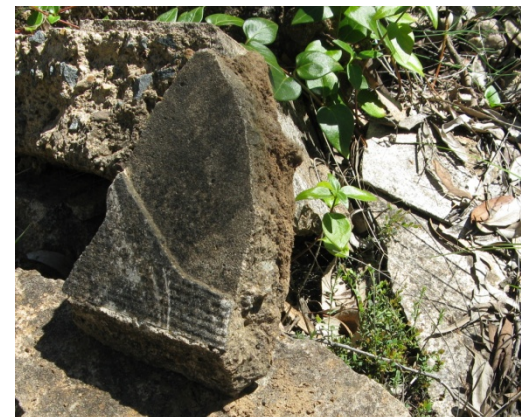
Asbestos in rural settings (cont)

- Building rubble buried following demolition of an old house or shed.
- Illegal dumping of asbestos sheeting
- Dumping of asbestos sheets in farm tips
- Importing asbestos impacted fill for general earthworks
- Used as formwork for concrete structures

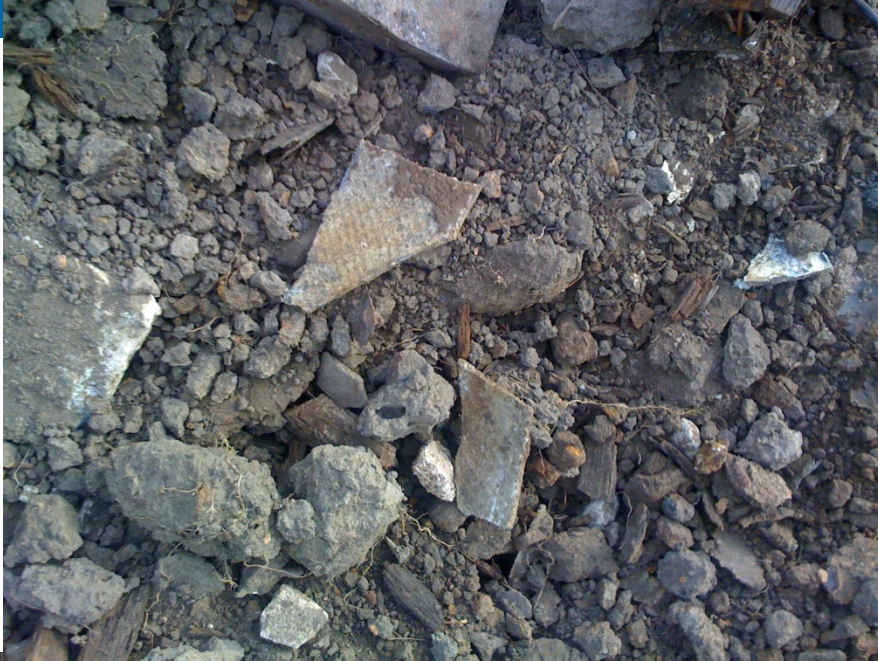
- Non-friable asbestos in fill (with other building rubble)

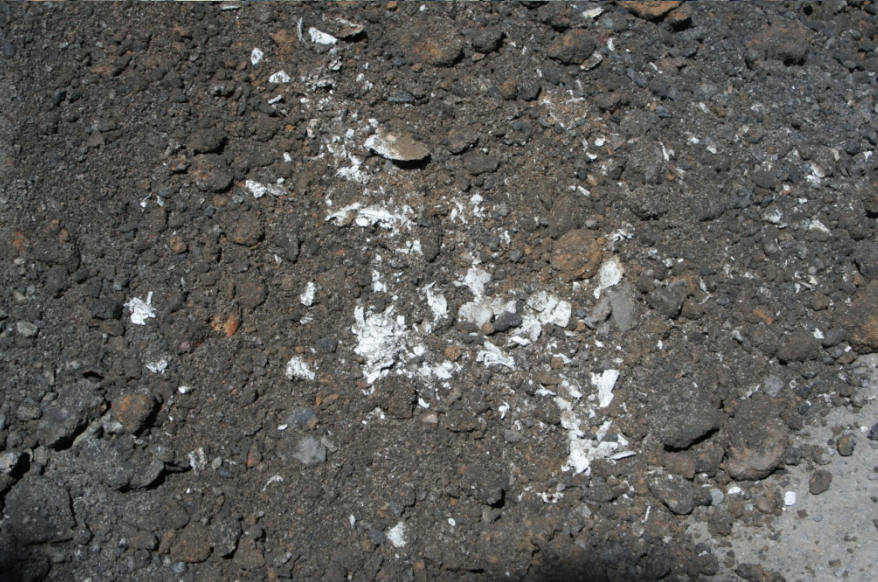
- Old non-friable asbestos which becomes friable as the cement weathers
